SUBJECT: Site Inspection, Cane Creek Mine, Moab Salt, LLC, M/019/005, Grand County, Utah

Date of Inspection: May 11, 2004
Time of Inspection: 12:30 to 3:30 p.m.
Conditions: Cloudy, 60's, a few rain showers
Participants: Rick Klein (Moab Salt), Paul Baker, (DOGM)

The Division is reviewing a revised reclamation plan, and I wanted to look at some of the drill sites, the tailings pond, the proposed landfill, and one of the cutoff dams.

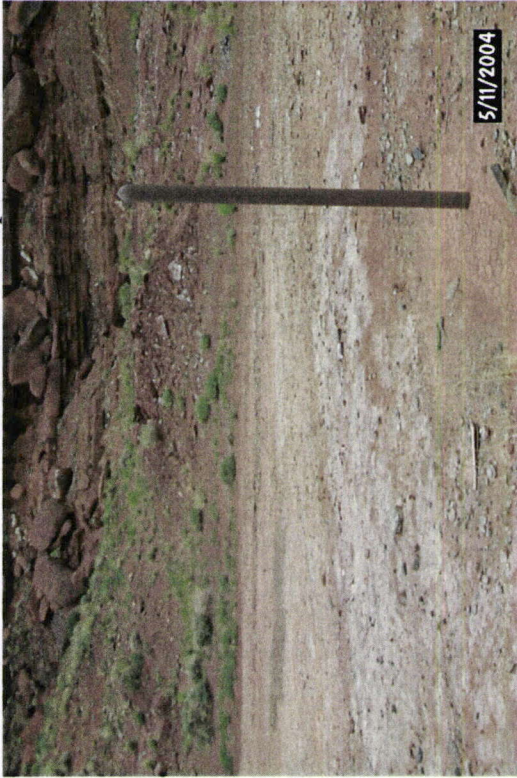
We visited about five well sites, and three are shown in Photos 1 through 3. At all but one of these sites, there was a salt crust in an area within about 15-20 feet of the well. Outside this circle, there were thin layers of soil with some vegetation consisting of mostly shadscale and Indian ricegrass. This soil appears to have been eroded in to these areas.

Photo 1. One of the reclaimed wells. In this picture and in Photo 2, note the salt crust near the hole and the encroaching vegetation, even on very shallow soils.

It is not certain exactly how far from the reclaimed wells the surface salt contamination extends and whether it is under the thin soil layers that have accumulated. I believe it is under this soil, and, if so, remediation of the salt contamination may be much easier than previously thought. The plan the Division is currently reviewing says salt-contaminated soils will be dug up and disposed of in the landfill, and replacement soil will be brought in.

I recommend that the operator try placing a few inches of soil over some salt-contaminated soil, leaving the surface rough without disturbing the salty soil, seeding it, and watching to see what can grow and survive. Some testing of the soil might also be useful to see how deeply any contamination extends.

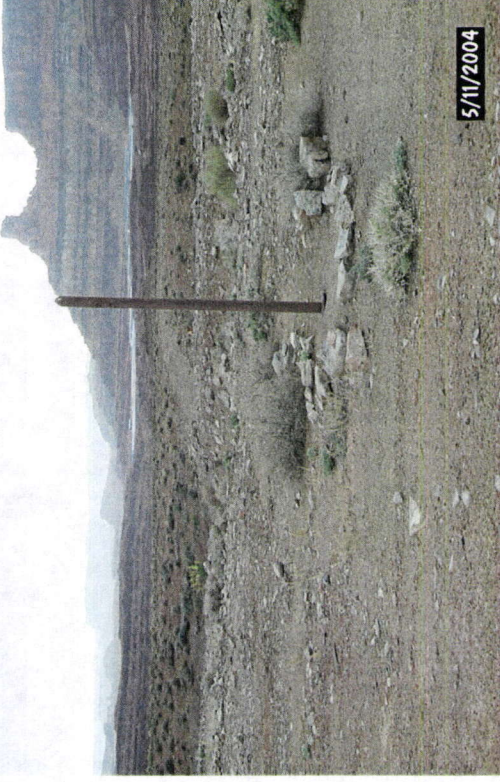
Photo 3. This well is in an exposed location with little vegetation except what can be seen near the well.

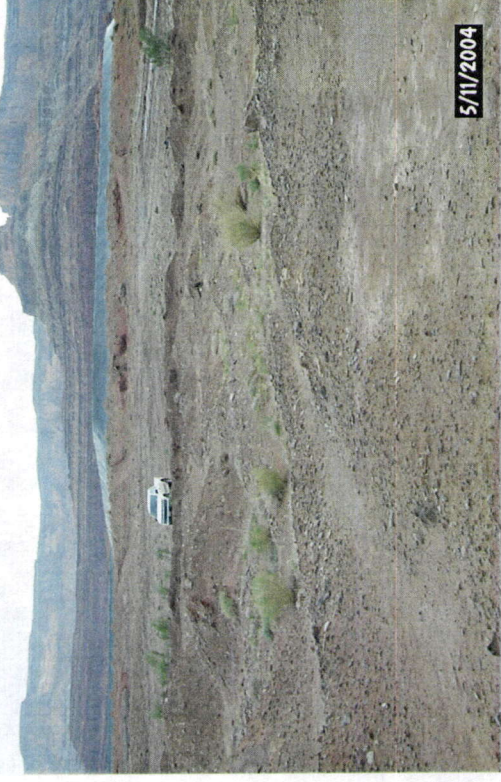
We visited an area where, a few years ago, soil was brought up from near one of the cutoff dams (Photo 4). This soil was probably contaminated with salt, and although no revegetation efforts were made, there was some shadscale, rabbitbrush, and Indian ricegrass. It was my general impression that the amount of vegetation was dependent on the terrain and that the hummocky areas had more vegetation.

Photo 4. Material brought up from near one of the cutoff dams. It was just piled here with no revegetation efforts, but note the amount of vegetation.

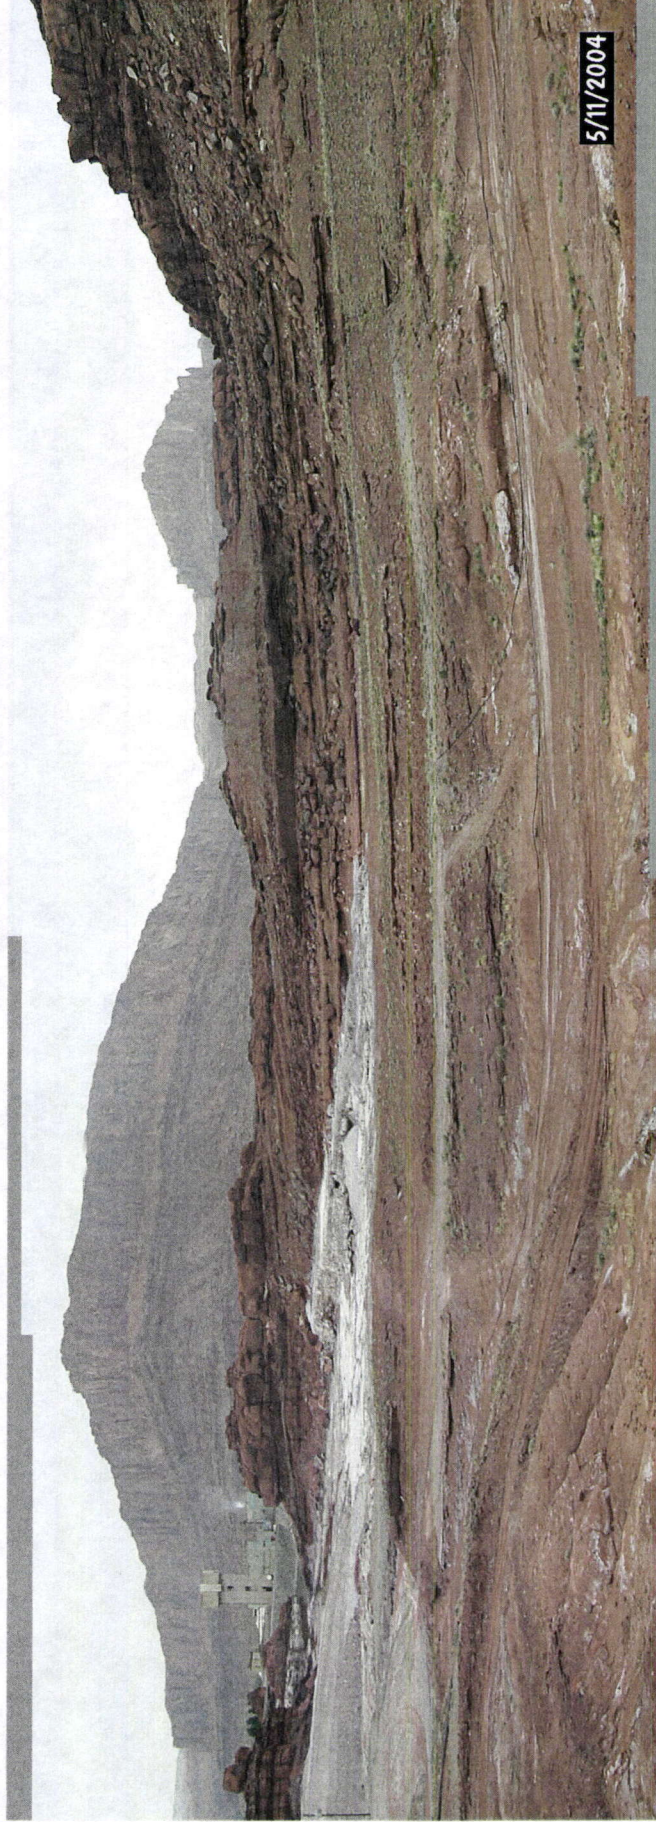
Mr. Klein said the operator is working to change the plan for the landfill. The plan currently being reviewed by the Division shows demolition waste and some other material being disposed of in a canyon on the southeast side of the tailings pond. Mr. Klein showed me another area (Photo 5) with better access that is now being considered both as an area for disposal of demolition debris, and to dispose of some waste from the operation.

Soils in a large portion of the proposed landfill have been affected by salts from the tailings pond. These soils should be rinsed before being used for revegetation.

It was difficult to tell how much soil would be available for reclamation in the area we examined. The upper portion of the area, the right side of Photo 5, has not been affected by the salt tailings pond, and there could be up to several feet of soil in this area. Other areas are covered by bedrock while others have intermediate quantities that could be saved. For the landfill in the proposal before the Division, the operator has estimated about two feet of soil could be placed over the landfill. There is probably about this same amount in the new area.

Photo 5. Panorama of an area that will be proposed as a landfill. The area that would be used is against the feature just above the center and toward the right of the photo.

At the time of the inspection, I did not realize or express some of the concerns the Division might have about the new landfill site. It is a relatively open area that could be seen from many nearby areas, but the canyon landfill would be more secluded. In the new area, debris would need to be pushed against

the hill and covered with soil, and there would probably be increased potential for erosion and exposing the trash. The operator might consider a landfill for the operations phase and keeping the canyon landfill for reclamation when access is likely to be easier.

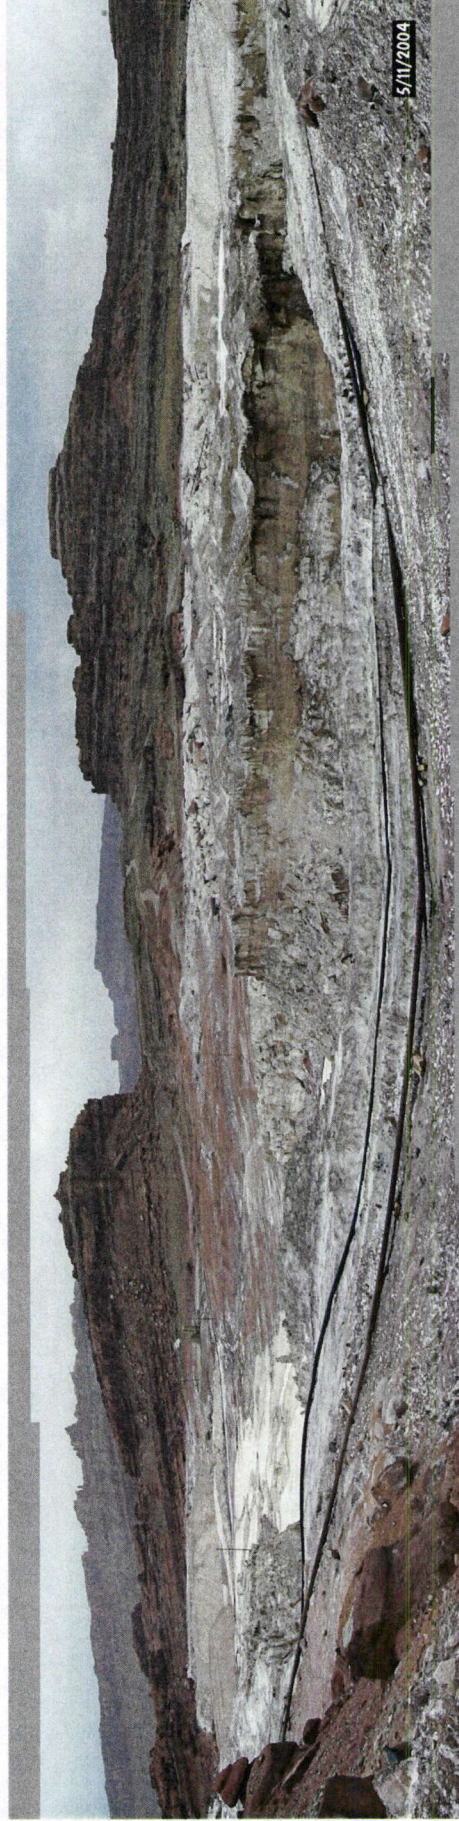
Photo 6. Panorama of the salt tailings pond looking approximately southeast.

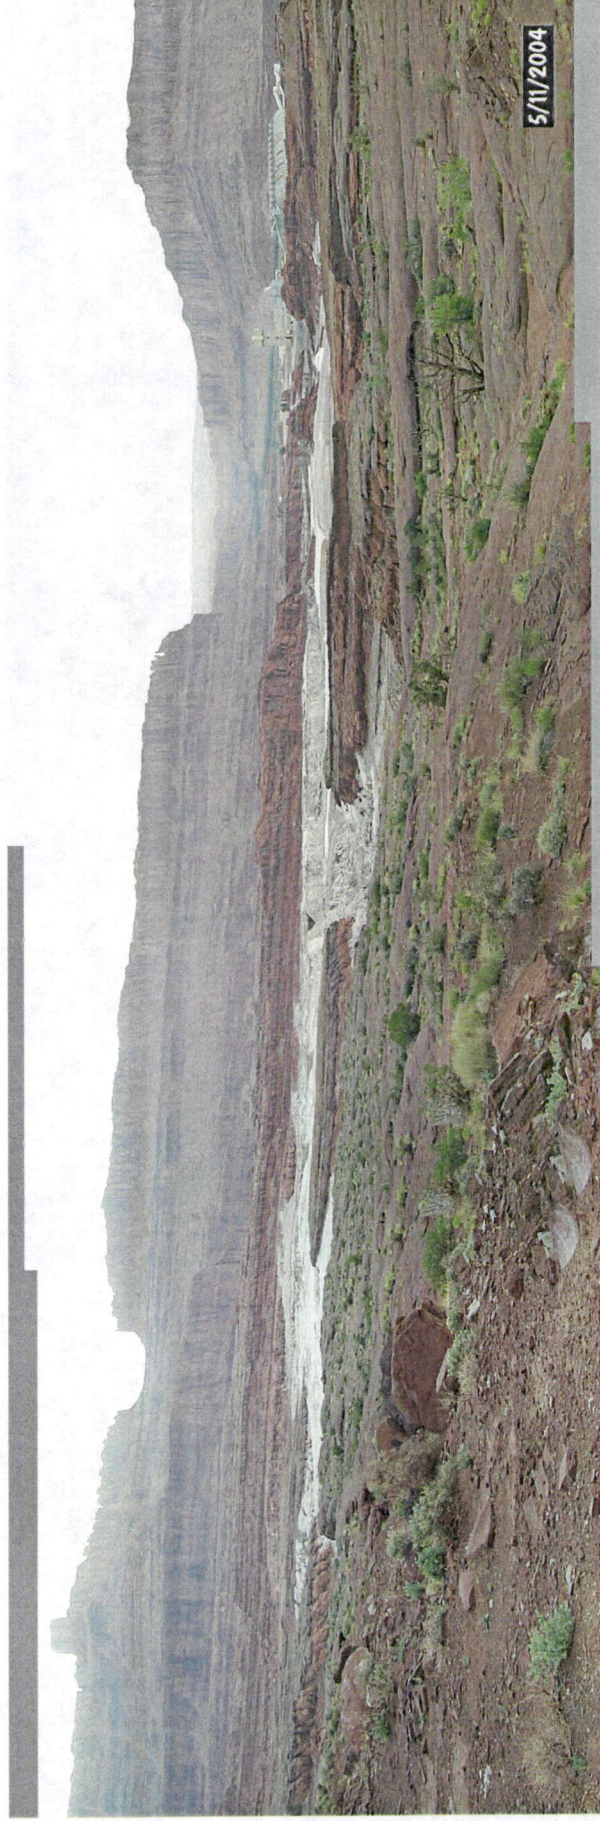
Photo 7. Panorama of the salt tailings pond looking approximately north or northeast.
